HAL_SPI_Receive function has a strange problem, a simple workaround can be implemented as a temporal solution but I need reason of the this behaviour.

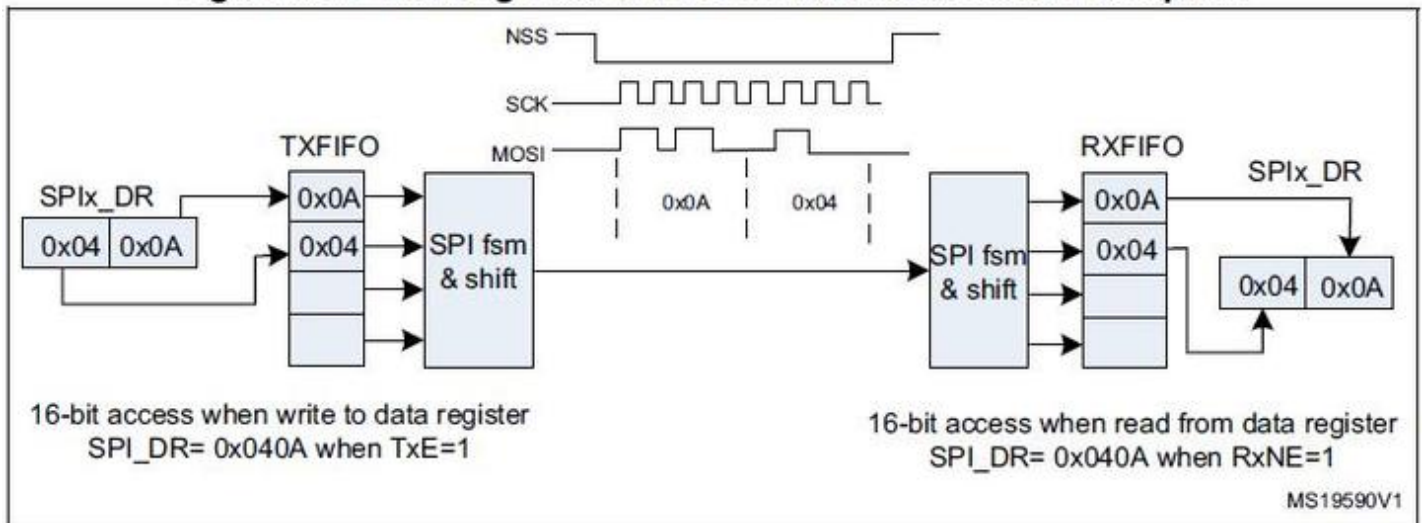
Figure 274. Packing data in FIFO for transmission and reception

What is the problem ? Is there a problem in CubeMx function that handling SPI data packaging described below ? Or any point that I am missing ?
