I'm getting "Bit Dominant Error" on every attempted transmission in the "CAN_MODE_SILENT_LOOPBACK" of "CAN1" in STM32F105RBT6. TEC's is then increased. REC is not being increased. I'm wondering if this is even possible, as this mode should route the TX line to RX internally, and the clock must be in sync, since this is the same peripheral? Also, what does "Bit Dominant Error" mean - peripheral tried to send dominant, but received recessive, or the other way around?

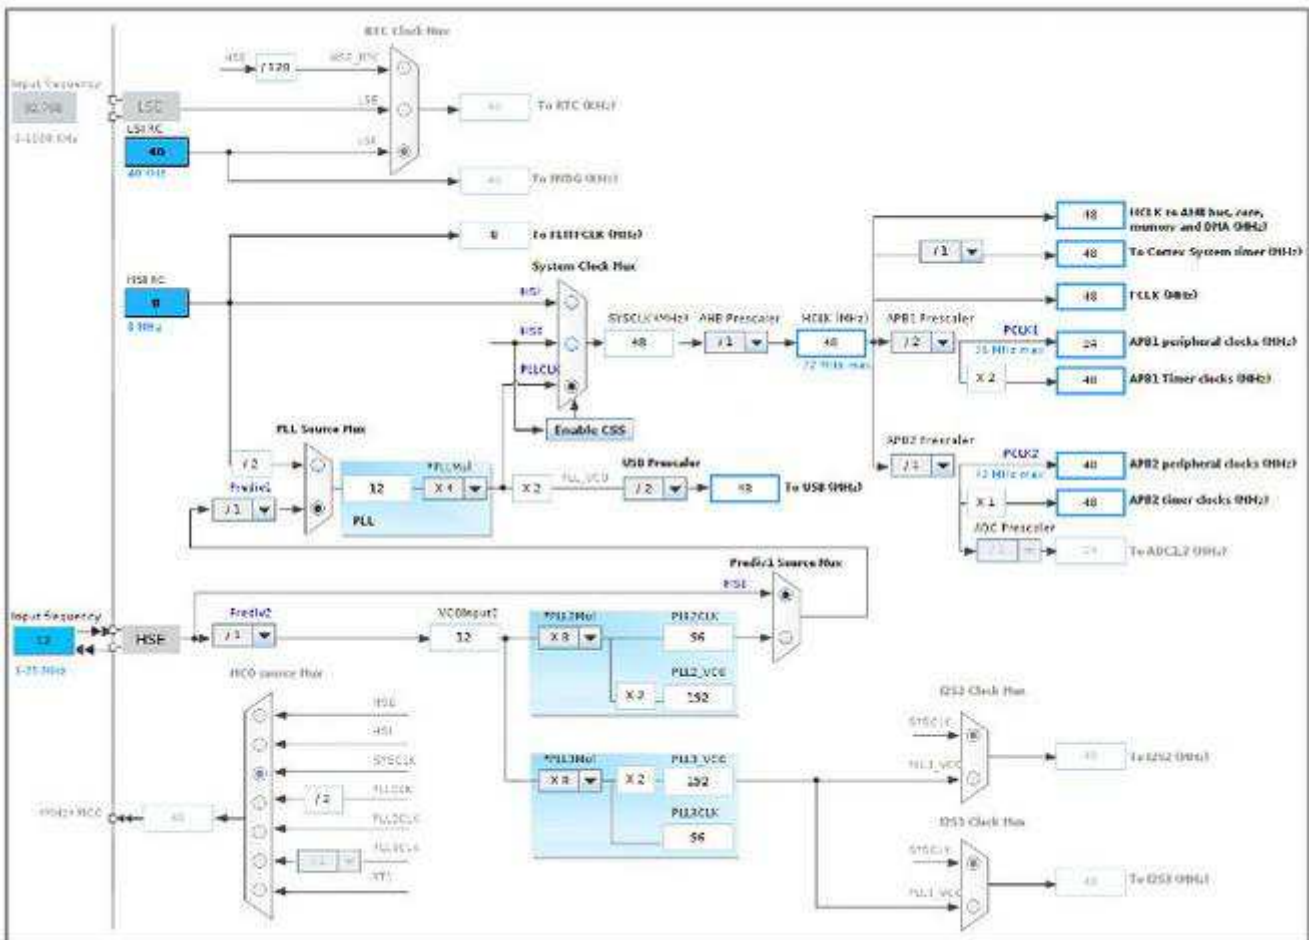
Below I'm pasting my code for CAN init and message sending. My USB-CDC in device mode is working correctly, so I think that clocks are set up fine. Please, help me find my mistake, or confirm that my hardware is most probably damaged.

I'm attaching my clock tree as well.
