I am working on a library for controlling the [M95128-W EEPROM](#) from an STM32 device. I have the library writing and reading back data however the first byte of each page it not as expected and seems to be fixed at 0x04 .

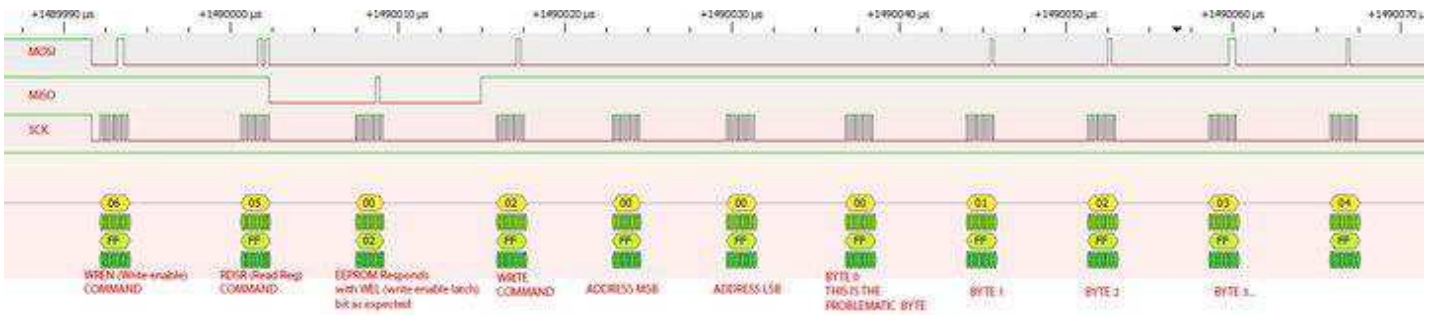
Here is a SPI logic trace of the write command:

I have debugged the SPI with a logic analyzer and confirmed the correct bytes are being sent. When using the logic analyzer on the read command the mysterios 0x04 is transmitted from the EEPROM.
