I am developing driver for ADC104S021 for STM32F103

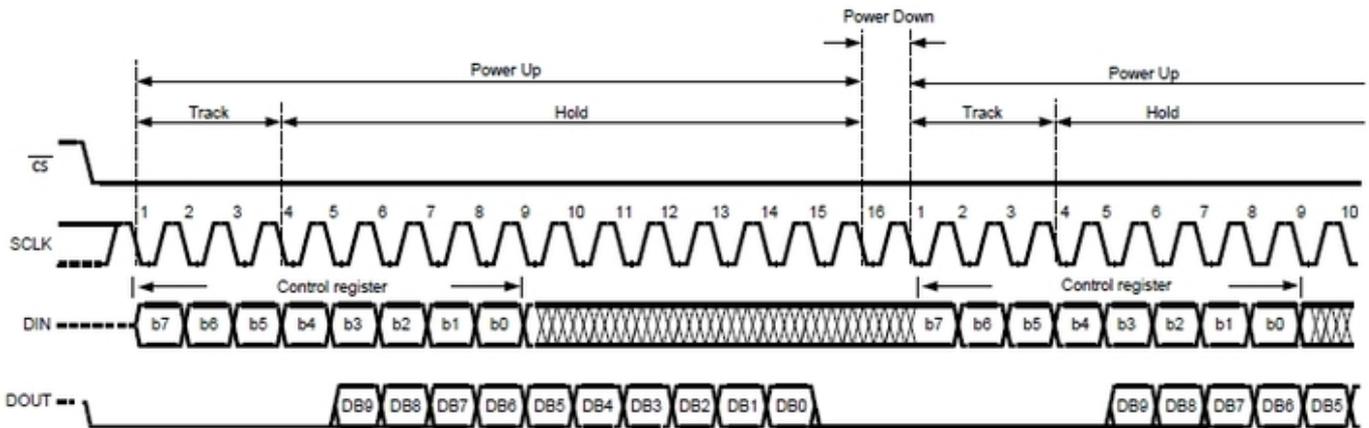
timing diagram as follows (from datasheet).

Figure 3. ADC104S021/ADC104S021Q Operational Timing Diagram

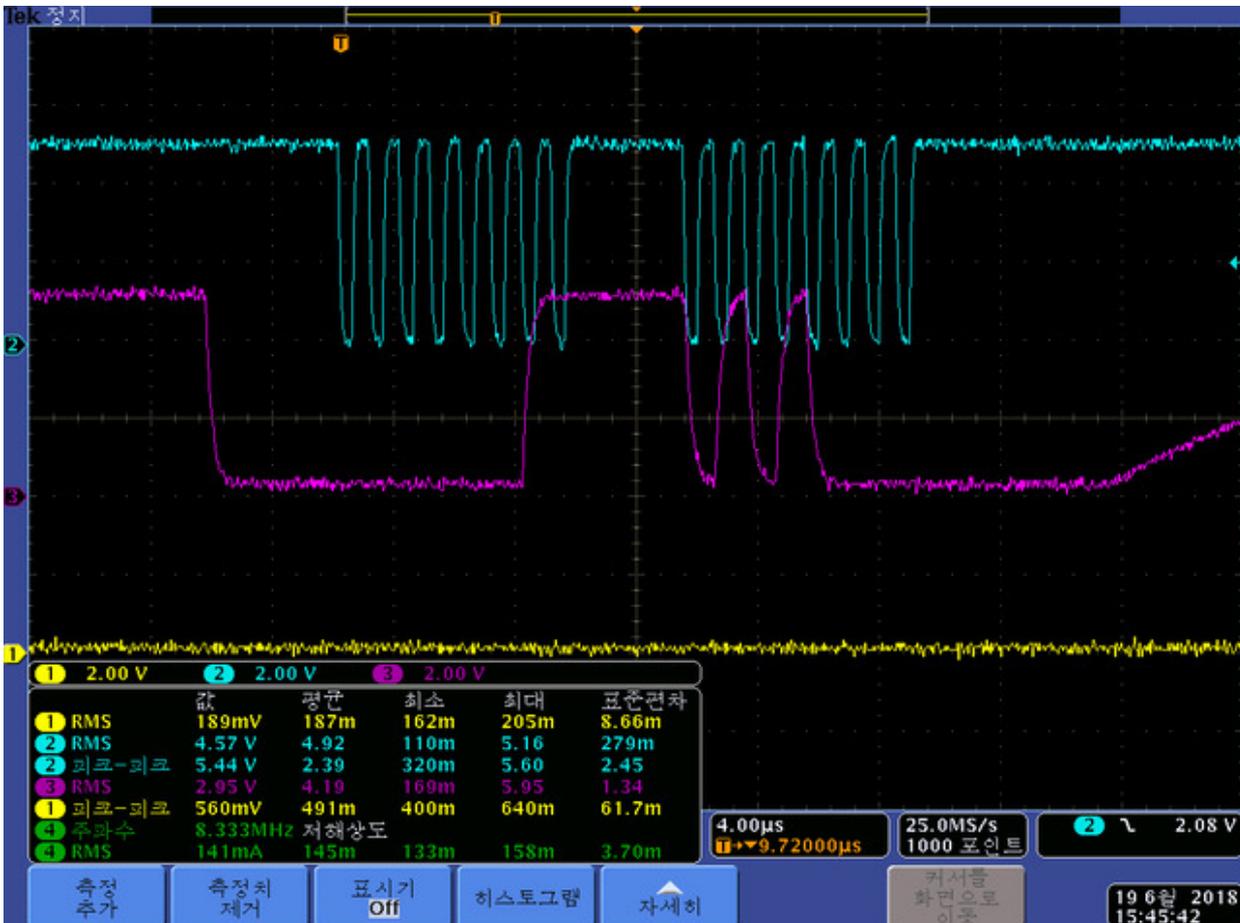
captured data from oscilloscope as follows.

As I read value from capture, it seems to be 0x2, 0x50, but printed log showed it as 0x2, 0xF9.

this is just example, all the values I've got from log are not matched with measured value from scope.
