SPI – bit shift issue in MISO line of STM32F303x

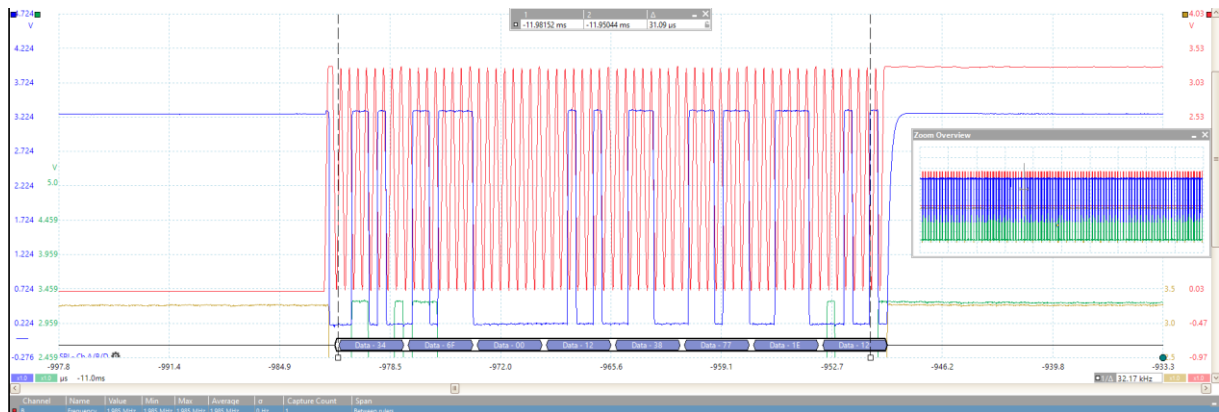
From the above picture (measured data from picoscope), the decoded SPI message from the MISO line is as follows,

0x34 0x6F 0x00 0x12 0x38 0x77 0x1E 0x12

For CRC, I am using the XOR checksum (CRC8). When I check the above message for the validity (using a normal xor checksum calculator online), the xor byte becomes invalid (0x12)

Moreover, the expected message is as follows-> 0x34 0x6F 0x00 0x12 0x38 0x77 0x0F, with a CRC byte value of 0x09.

If I observe the 7th byte -> 0x1E -> 0001 1110, 1-bit shift happened towards the left, as the expected value was 0F -> 0000 1111. This bit shift happens at the 8th byte (CRC) as well.

12 (invalid CRC) -> 0001 0010 (measured) -> 0000 1001 (expected) -> 09 (valid CRC).

The bit-shifting issue happens only on the MISO line of the SPI, when the current consumption is on a higher range (more than 20 A, for example).

The clock line does not get disturbed, as I always get valid messages on the MOSI. It should also be noted that the other functionalities of the slave (there are other measurements running in parallel) are unaffected.
