Processor: STM32L021D4

I am cycling the PWM frequency from 3.2KHz to 3.7KHz in 15mS steps and then repeating but I am hearing short pauses from the piezo circuit connected to the output. I have trapped the pwm output on the logic analyzer which shows periods that the pwm is not functional. The error always happens after updating the frequency but it is random. The times that the PWM stops is almost always 32mS in length. When the PWM output stops, the pin's output state is dependent on the values in the OC3M bits of the TIM2->CCMR2 register which leads me to this excerpt from the reference manual?

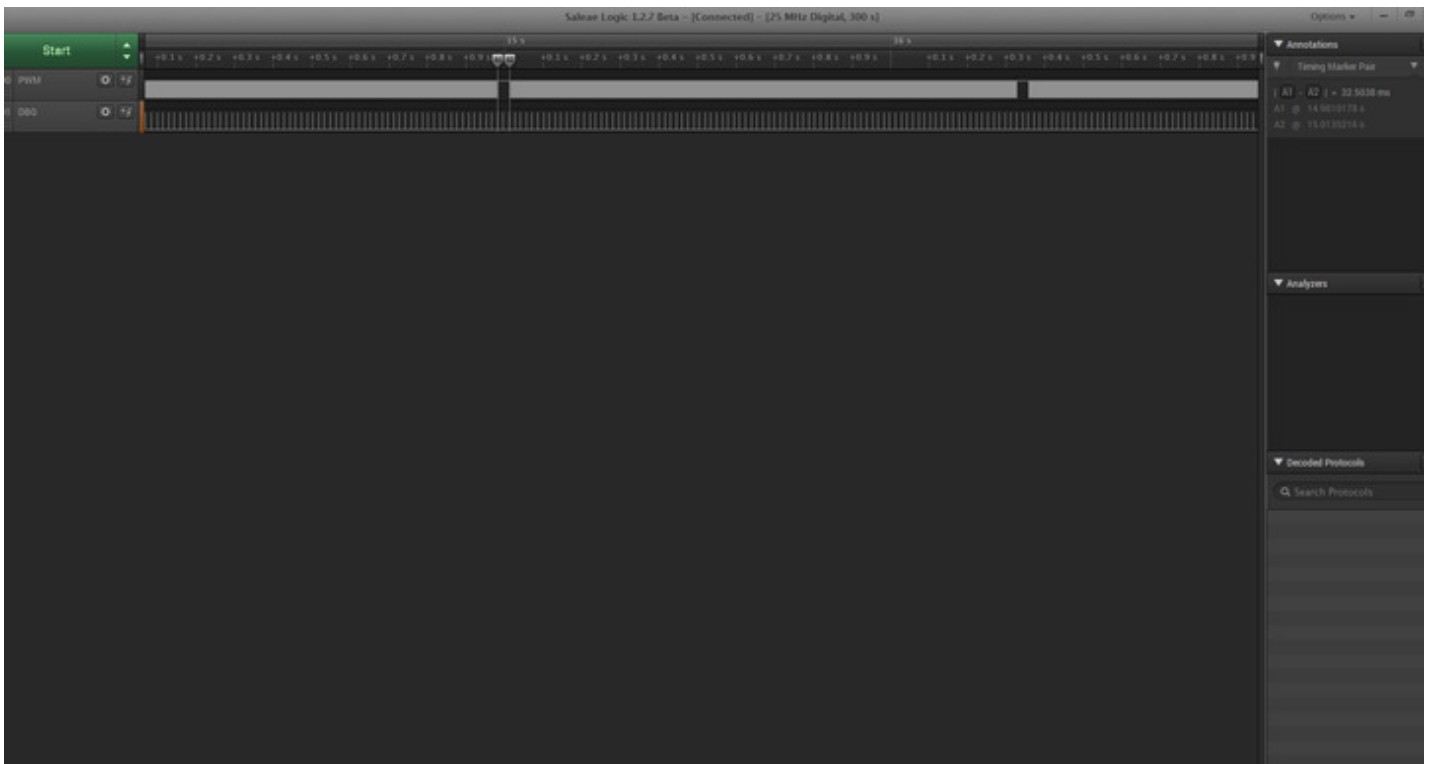
I tried a constant output and it is good so it is definitely related to switch frequencies. The source code has been condensed to a couple sample functions to eliminate other interference. In the capture below, the DBG line is toggled every 15mS when changing frequencies which shows the program is running as normal.
